Installation Instruction for GM 4L80E Transmission Harness with Temperature Sensor

Form #4157, Rev. C, 12-03-10

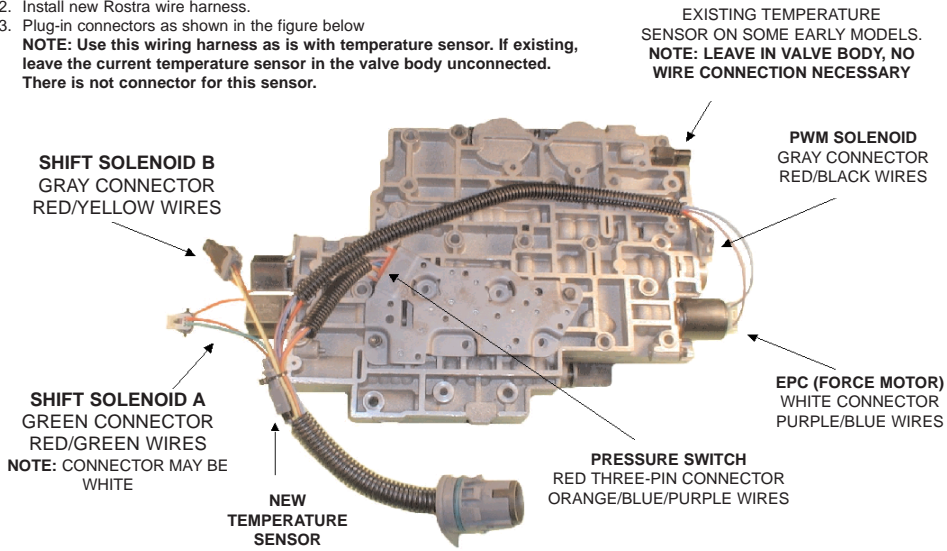
1. Remove old wire harness from valve body.
2. Install new Rostra wire harness.
3. Plug-in connectors as shown in the figure below
NOTE: Use this wiring harness as is with temperature sensor. If existing, leave the current temperature sensor in the valve body unconnected. There is not connector for this sensor.

NOTE: FOR PRE 1993 VEHICLES, EXTERNAL HARNESS MUST BE CONVERTED TO LATER STYLE CONNECTOR USING ROSTRA PART #350-0033, 4L80E EXTERNAL HARNESS REPAIR KIT

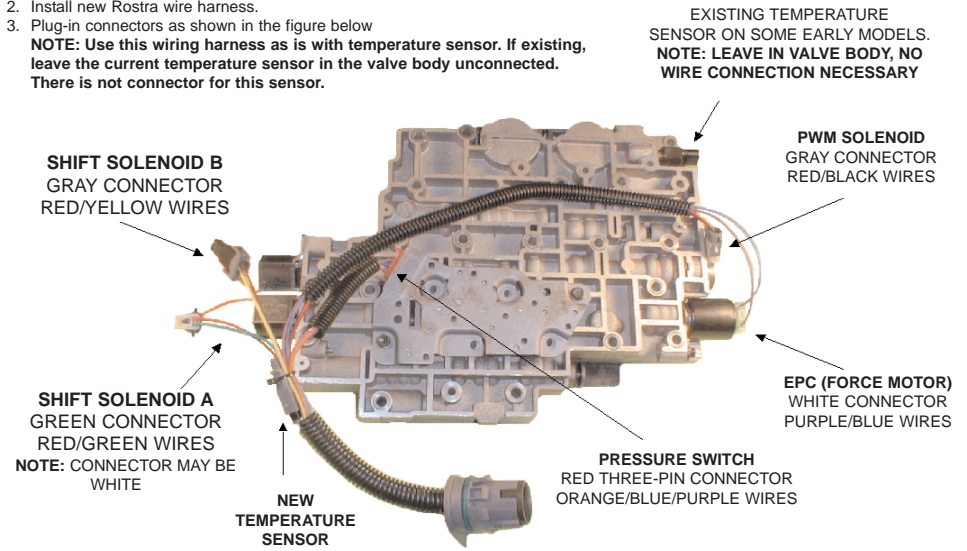
1. Remove old wire harness from valve body.
2. Install new Rostra wire harness.
3. Plug-in connectors as shown in the figure below
NOTE: Use this wiring harness as is with temperature sensor. If existing, leave the current temperature sensor in the valve body unconnected. There is not connector for this sensor.

NOTE: FOR PRE 1993 VEHICLES, EXTERNAL HARNESS MUST BE CONVERTED TO LATER STYLE CONNECTOR USING ROSTRA PART #350-0033, 4L80E EXTERNAL HARNESS REPAIR KIT

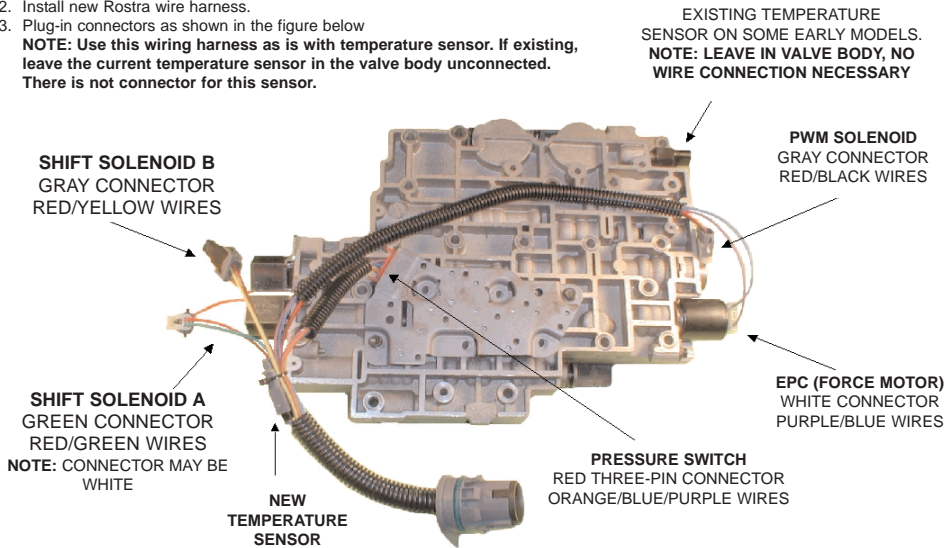
1. Remove old wire harness from valve body.
2. Install new Rostra wire harness.
3. Plug-in connectors as shown in the figure below
NOTE: Use this wiring harness as is with temperature sensor. If existing, leave the current temperature sensor in the valve body unconnected. There is not connector for this sensor.

NOTE: FOR PRE 1993 VEHICLES, EXTERNAL HARNESS MUST BE CONVERTED TO LATER STYLE CONNECTOR USING ROSTRA PART #350-0033, 4L80E EXTERNAL HARNESS REPAIR KIT

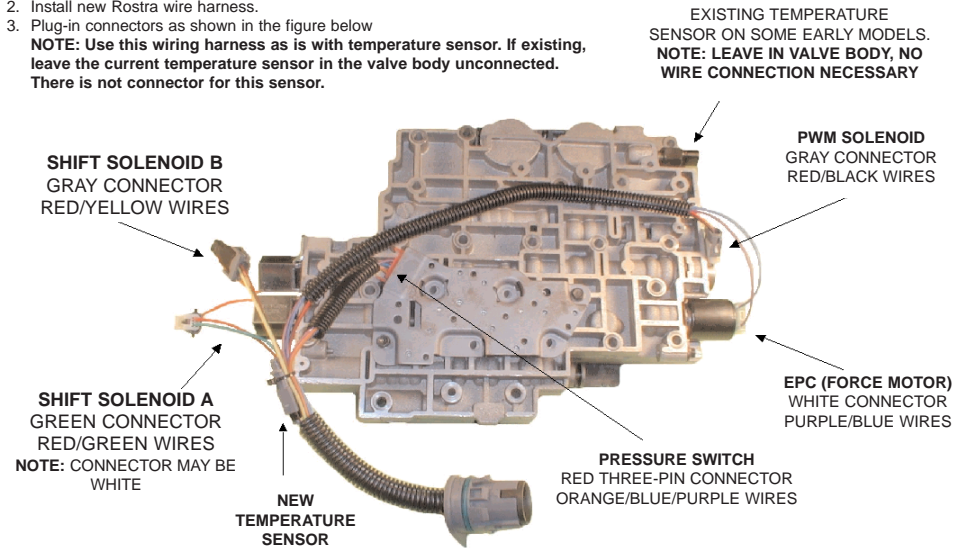
1. Remove old wire harness from valve body.
2. Install new Rostra wire harness.
3. Plug-in connectors as shown in the figure below
NOTE: Use this wiring harness as is with temperature sensor. If existing, leave the current temperature sensor in the valve body unconnected. There is not connector for this sensor.

NOTE: FOR PRE 1993 VEHICLES, EXTERNAL HARNESS MUST BE CONVERTED TO LATER STYLE CONNECTOR USING ROSTRA PART #350-0033, 4L80E EXTERNAL HARNESS REPAIR KIT
